ZOOM TKL uses nano-coating technology. Due to the technological properties of nano-coatings, there may be minor, unavoidable dust spots on the case surface. Small dust points and micro scratches are only visible at a particular angle. Dust spots in the case of a visual distance of 30cm, dot size <0.1mm, and the whole surface is not more than 2 spots are not covered in the after-sales service.

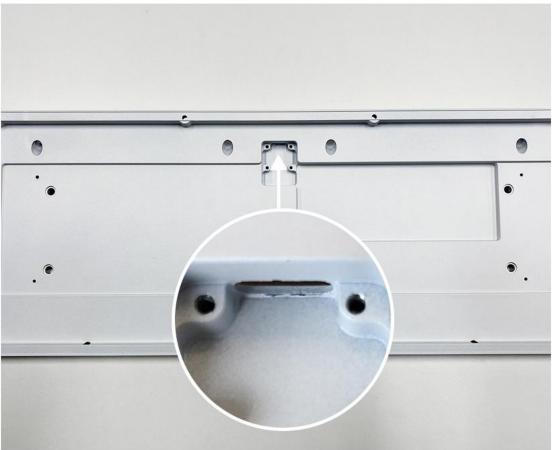
1. This is an example of a minor dust spot.

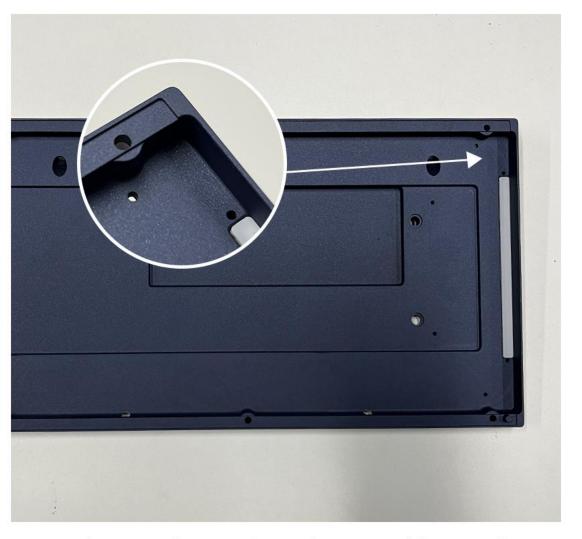
4. Due to the nature of CNC machining, the interior of the top and bottom case may have slight, inevitable processing knife marks/minor scratches, the invisible processing knife lines/scratches after the keyboard is fully assembled will not affect the aesthetics, which is within the range of our quality acceptance.
