Service

Structure

Fault clearance by fault pattern

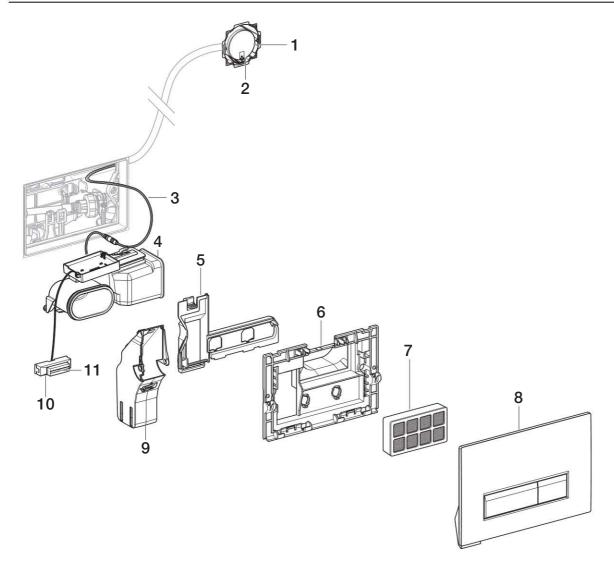
- 1 Power supply unit
- 2 LED power supply unit3 Plug connection between extraction unit and power supply unit
- 4 Extraction unit
- 5 Protection plate
- 6 Mounting frame
- 7 Active carbon filter
- 8 Actuator plate with hinged frame
- 9 Receptacle for in-cistern block
- 10 Button for odour extraction unit
- 11 LED on button for odour extraction unit
