Ontario Structure Inspection Manual (OSIM)  
Bridge Inspection Report  
Township of Stone Mills

Prepared by:  
Jewell Engineering

Dated October 22, 2020

RE: Cataraqui Region Conservation Authority  
2020 OSIM Bridge Inspection Submission  
Our File No. 200-9678

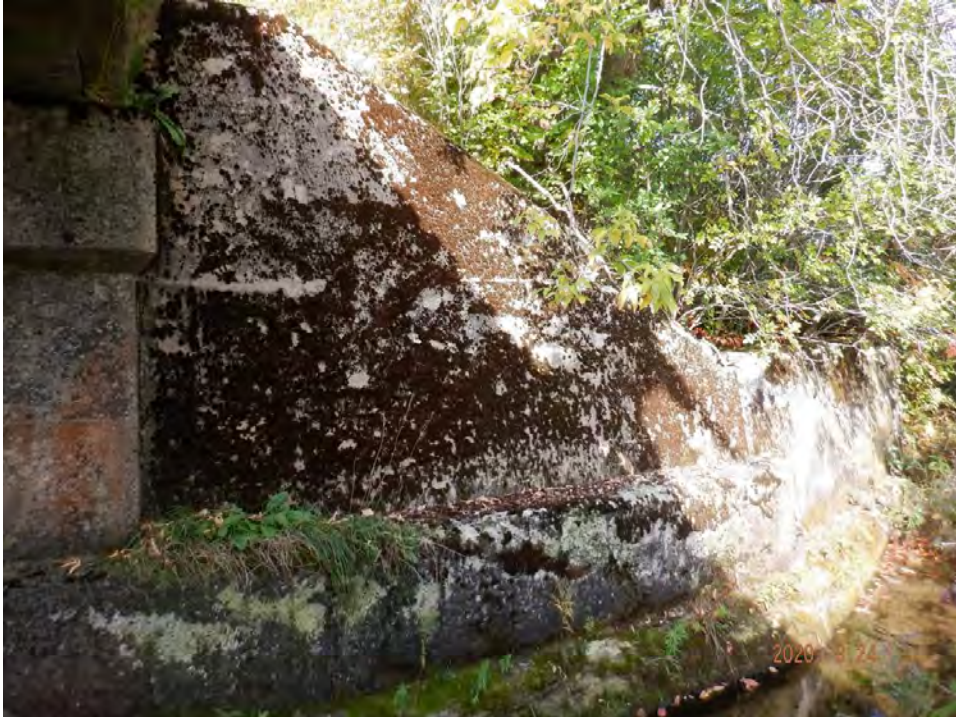
northwest wingwall

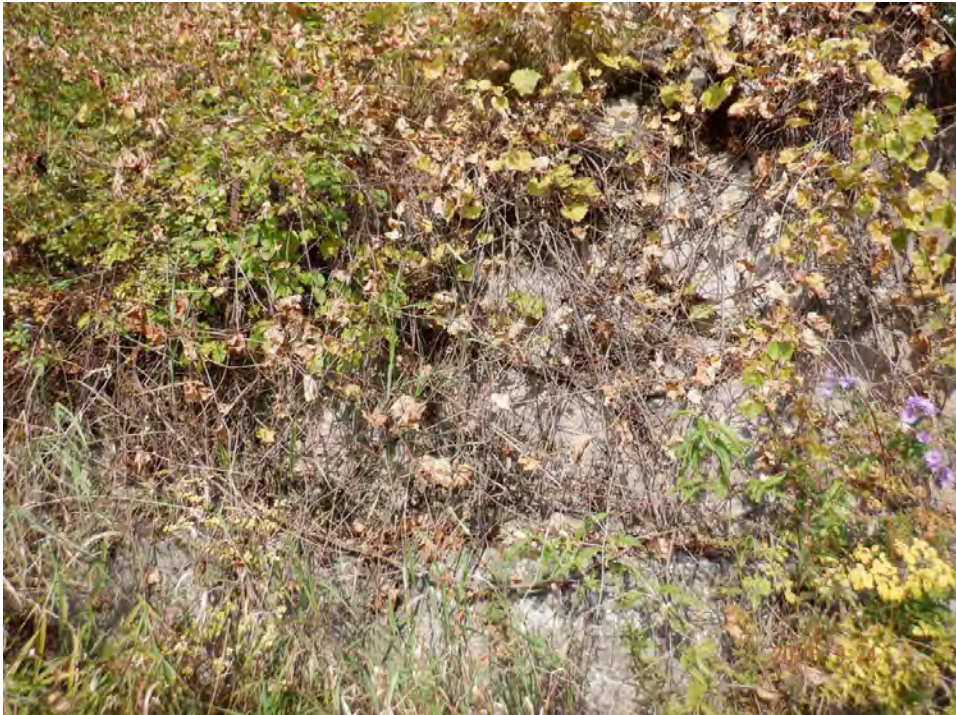
Southeast wingwall

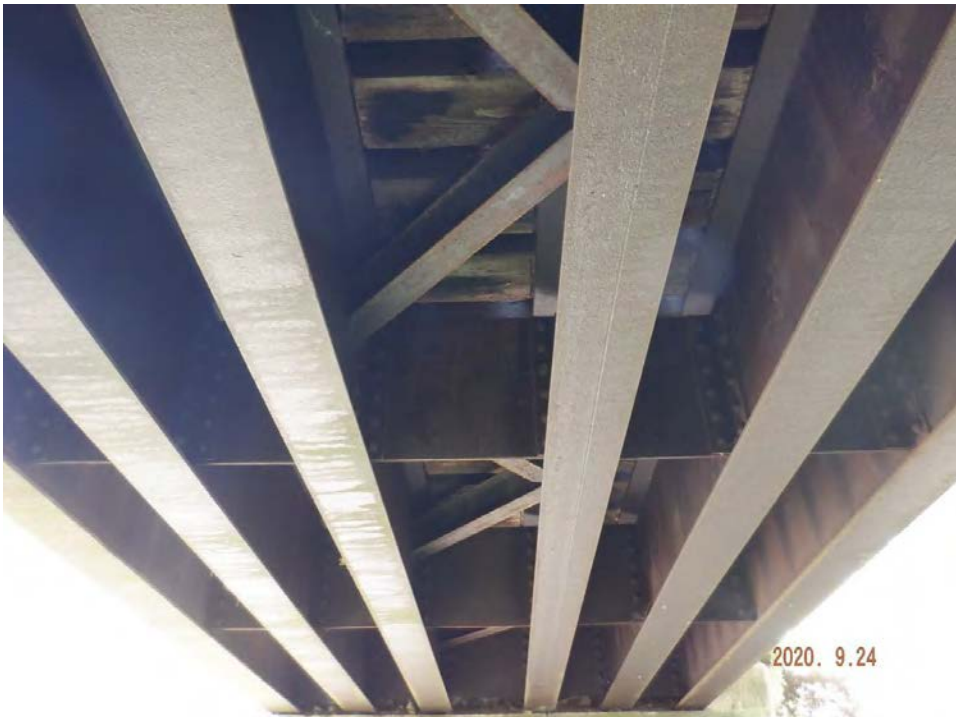
Typical soffit detail

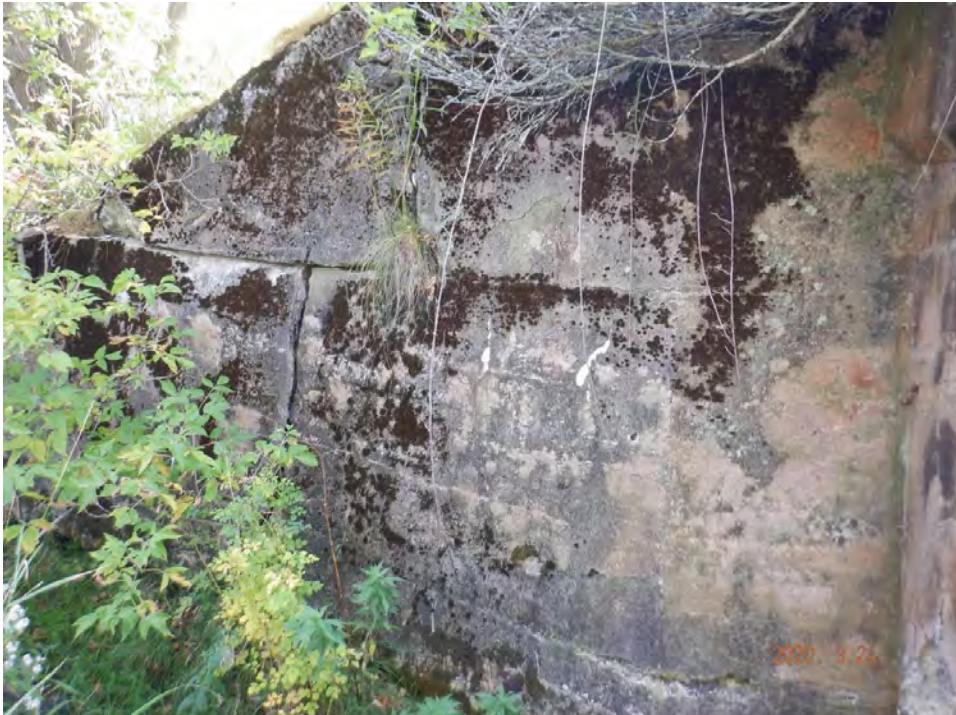
Southwest wingwall

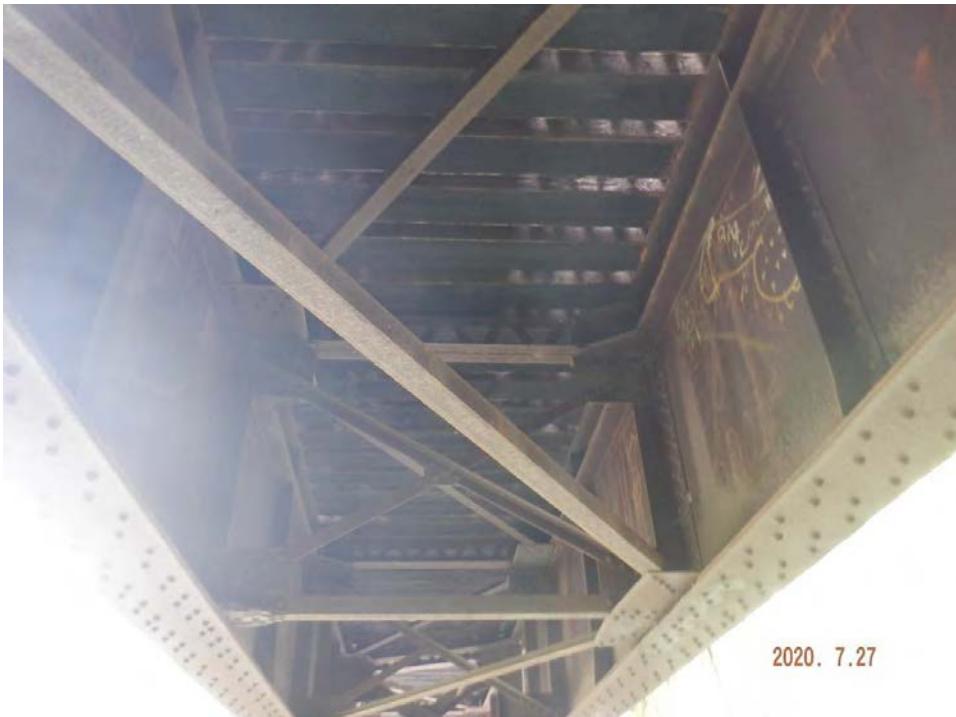
Perforated diaphragm section in northeast

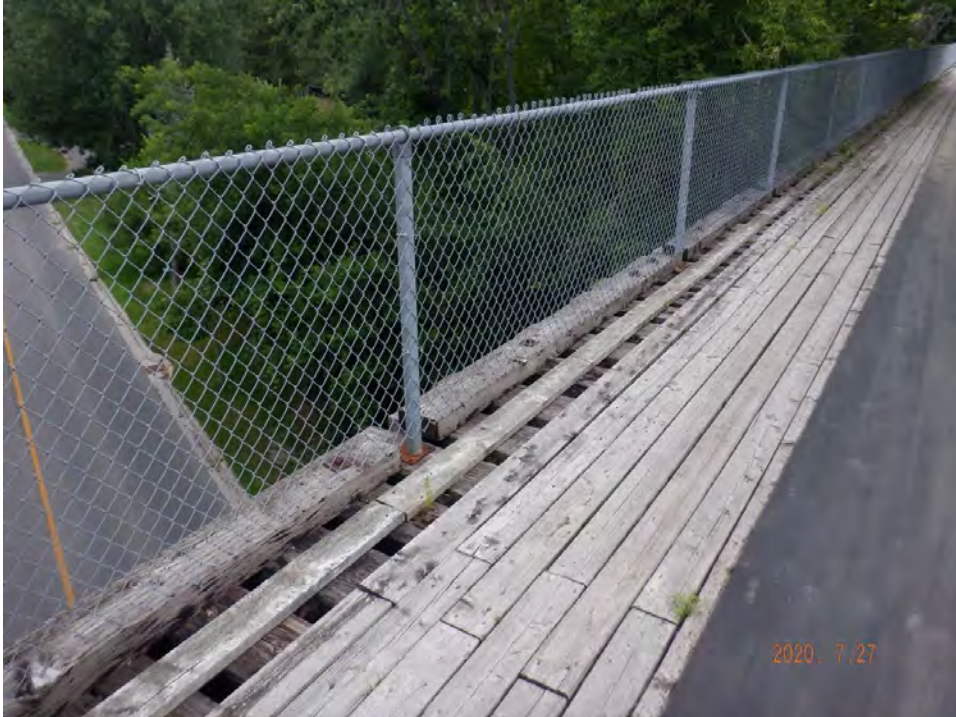
Chain-link fence railing

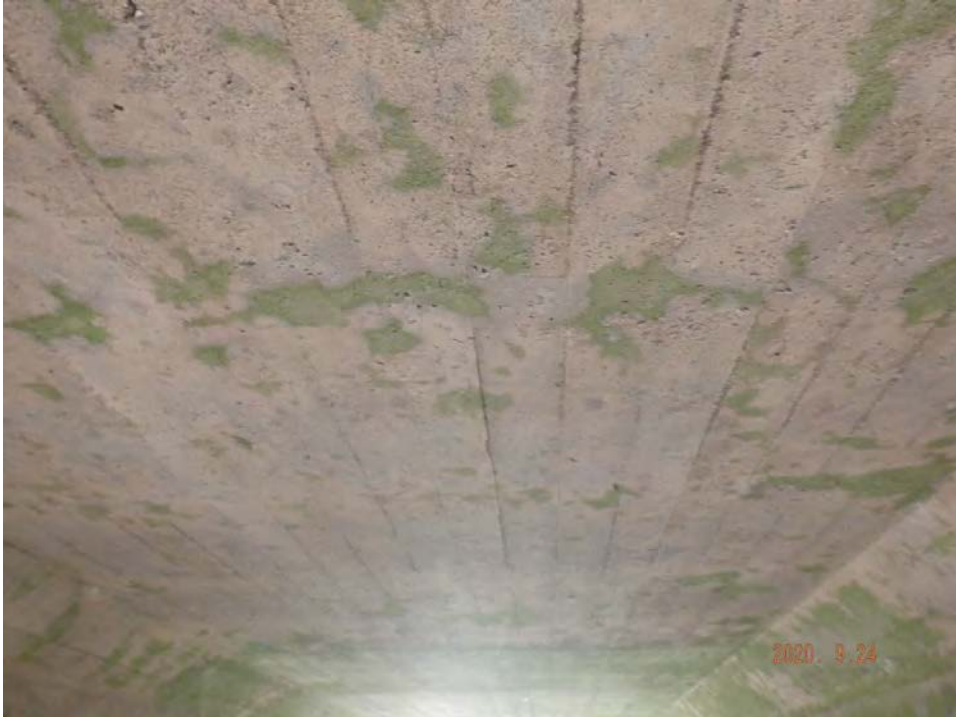
Typical soffit detail

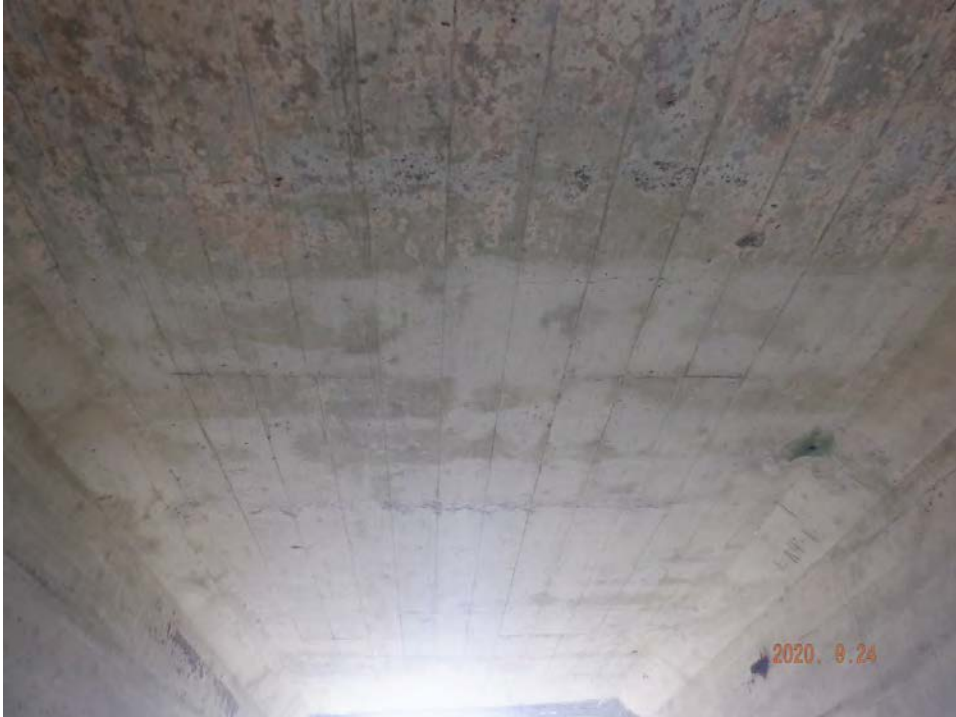
Typical soffit detail
